UNITED STATES AIR FORCE
AIRCRAFT ACCIDENT INVESTIGATION
BOARD REPORT

SC-7 SKYVAN III-200, T/N N46LH
17TH SPECIAL TACTICS SQUADRON
24TH SPECIAL OPERATIONS WING
FORT BENNING, GEORGIA

LOCATION: ELOY, ARIZONA
DATE OF ACCIDENT: 21 FEBRUARY 2014
BOARD PRESIDENT: MAJ GEN J. MARCUS HICKS
Conducted IAW Air Force Instruction 51-503

SUMMARY OF FACTS AND STATEMENT OF OPINION
SC-7 SKYVAN III-200, T/N N46LH
21 FEBRUARY 2014

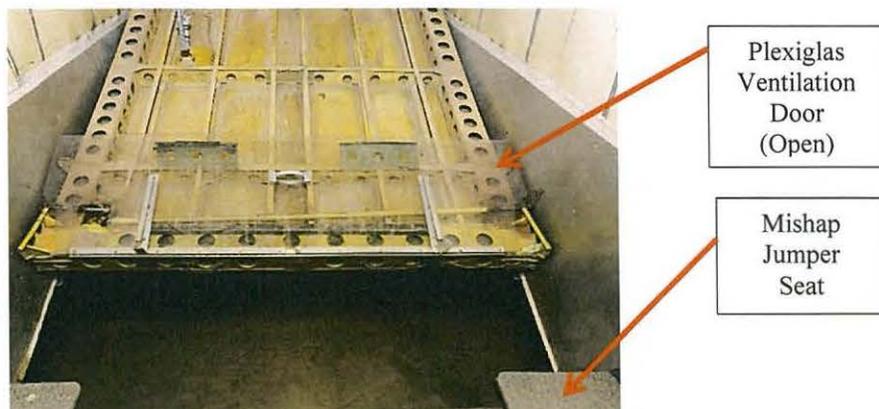
At approximately 0842L the MA departed the airfield en route to the Drop Zone (DZ) near Eloy, AZ (Tabs K-14, V-16.5). En route to the DZ with the MA approaching 9,700 feet MSL, the MJ stood and gave the “10 minute” warning and winds call, followed by the “don equipment (rucksack)” command as planned (Tabs V-1.4, V-3.10, V-4.15, V-6.25, V-7.5, V-8.4, V-16.5, Z-3, Z-4). The MJ then opened the Plexiglas ventilation door between the aft cargo door and aircraft floor, as allowed by SkyDive Arizona guidance, and sat down on the seat next to the door to don his own rucksack (Tab V-1.3, V-1.4, V-1.5, V-3.4, V-3.5, V-3.8, V-6.8, V-6.17, V-8.9, V-11.4, V-12.4). The cargo door was not opened immediately after opening the ventilation door (Tab V-1.4, 4.11, V-6.8, V-6.13, V-6.14, V-7.5, V-8.4). Testimony indicated that the Plexiglas door was likely opened without also opening the cargo door, at least in part, because the cabin was beginning to get warm and/or because there were fumes (Tab V-4.11 and V-6.8). According to SkyDive Arizona guidance, it was common practice to open the Plexiglas door for ventilation above 1,500 feet AGL (Tab V-3.4, V-8.3, V-11.4, V-16.6, V-16.7). No evidence indicates that there was any requirement to don equipment prior to opening the Plexiglas door, nor any requirement to open the ventilation door in conjunction with the cargo door.

Figure 4.1 Skyvan cargo door with Plexiglas ventilation door (Tab S-4)

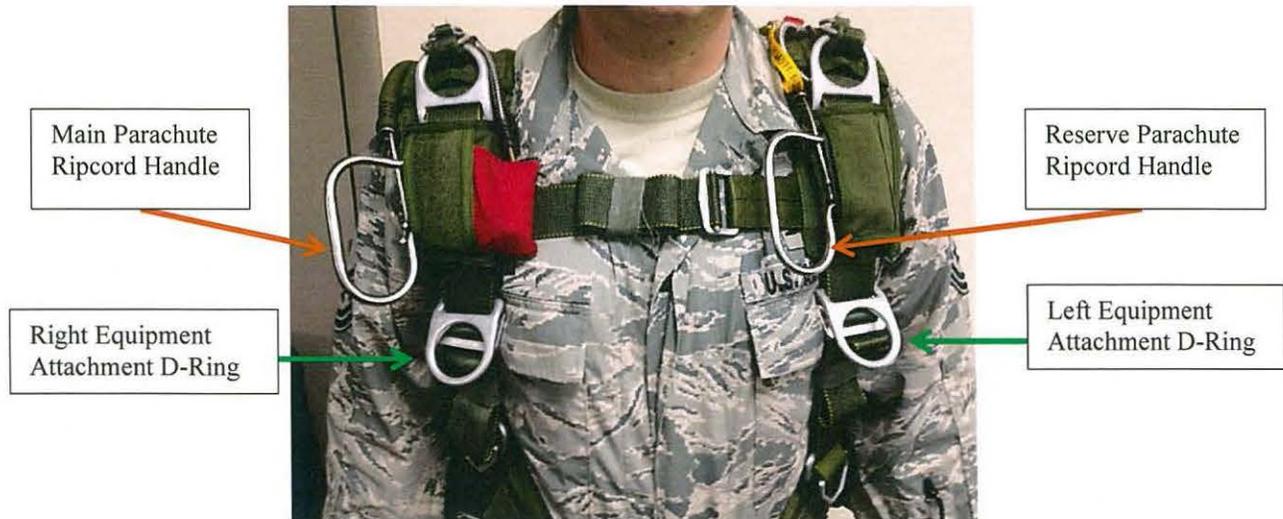
Figure 4.2. MC-4 parachute ripcord handles and equipment D-rings

The characteristics of the MC-4 equipment attachment D-rings, which are similar in appearance, feel, and location to the lower portion of the ripcord handles, make it relatively easy to either (1) attach equipment inadvertently to a ripcord handle instead of the D-ring, or (2) catch equipment inadvertently on a ripcord handle while attempting to attach equipment to the D-ring (see Figures 4.2, 4.3 and 4.4) (Tab GG-6, GG-7). This is exacerbated by wearing gloves, decreasing tactile feedback, and is more pronounced with the reserve ripcord handle, which is inboard of the left lift web, in line of sight from the parachutist's perspective (compare Figures 11.2 and 11.3) (Tab GG-7). At the time of the mishap, the MJ was seated, hooking up his rucksack and wearing Neumann Skydiving tackified gloves (Tabs V-1.4, X-3).

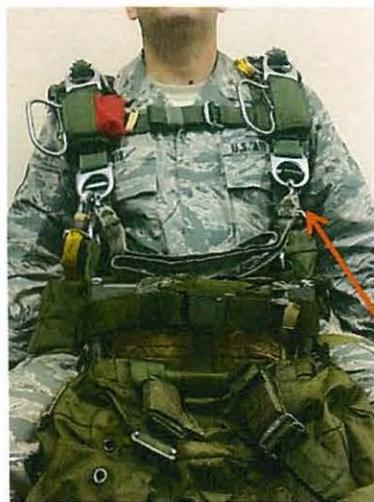
Figure 4.3. Proper Configuration

- Reserve Top Closing
- Reserve Ripcord Handle (lowered)
- Rucksack Quick-release Shackle

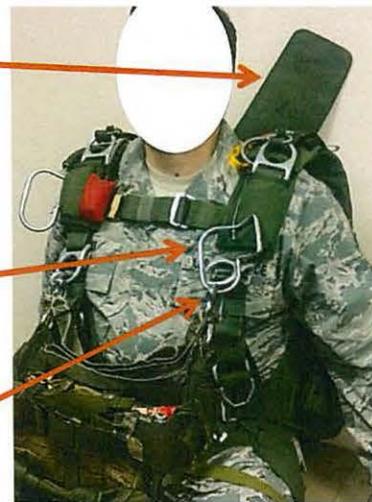
Figure 4.4. Reenactment of MJ Configuration Based on Witness Testimony

The reserve top closing flap had popped open above the MJ’s shoulder, but the pilot chute was still contained between the MJ and aircraft inner wall (Tab V-6.8, V-6.9, V-6.10, V-6.15, V-6.19, V-6.25). As the MJ leaned forward, the spring-loaded pilot chute popped up and fell directly through the open ventilation door taking the reserve parachute with it (Tab V-6.8, V-6.9, V-6.13, V-6.16, V-6.19, V-6.20, V-6.21, V-6.25, V-6.26). In roughly two seconds, the MJ was extracted through the ventilation door opening—tearing off his rucksack, damaging the aft cargo door, and killing him instantly when he hit the ventilation door opening. (Tabs V-1.4, V-4.11, V-6.9, V-6.19, V-6.21, V-6.26, V-7.5, V-7.11, V-7.12, V-8.4, V-10.8, S-2, S-5, S-6, U-3, X-3).

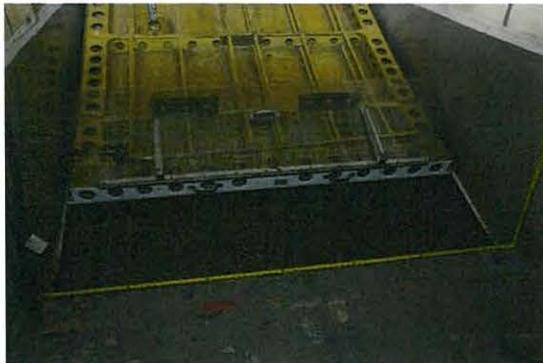
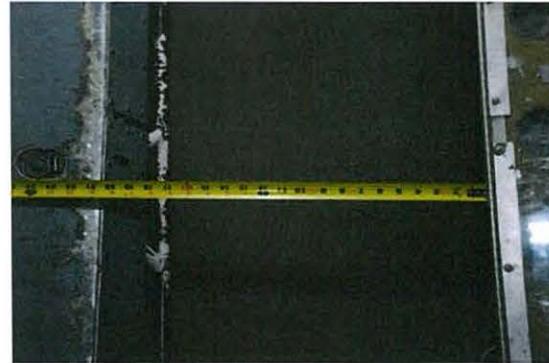
The dimensions of the ventilation door opening are 77.5 inches by 20.5 inches, looking down at the opening (Figures 4.5 and 4.6). The space narrows to about 77.5 inches by 17 inches looking straight down due to the angle of the aircraft frame and a step bar mounted below the floor (Figure 4.6). The space is only about 2 inches high if an observer looks at the space from the floor and directly aft, in the direction of force imparted by a trailing parachute (Figure 4.7).

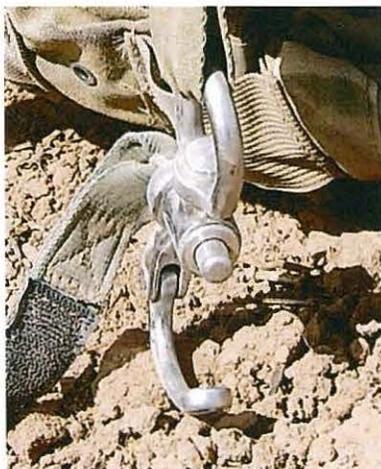
Figure 4.8. Left Quick-Release Shackle
(Tab S-6)

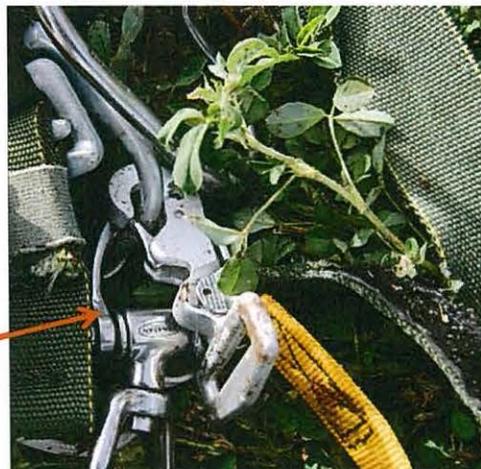
The MC saw that the MJ was motionless with his head down (Tab V-3.11, V-10.7, V-15.6, V-16.6). The MP and MC continued to coordinate emergency response from the MA while the MJ was still under canopy (Tab V-3.11, V-10.8, V-15.3, V-16.5). The MJ landed under a fully inflated, uncontrolled reserve parachute at approximately 0905L, southeast of Eloy, AZ (Tab V-3.11, V-7.12, V-8.4, V-15.3, V-17.3, V-17.7). His rucksack landed separately with the left quick-release shackle still attached to the rucksack and open (Figure 4.8), indicating it had not been connected to either the D-ring or the reserve ripcord handle, or had been released at some point during the extraction sequence (Tabs S-6, V-10.8). The right side rucksack hardware—the equipment lowering line ejector snap and right quick-release shackle—were torn off the MJ's rucksack during the extraction and remained attached to the parachute's right equipment attachment D-ring (Figure 4.9, Tab S-8).

Figure 4.9. Lowering Line &
Right Quick Release Shackle
(Tab S-8)

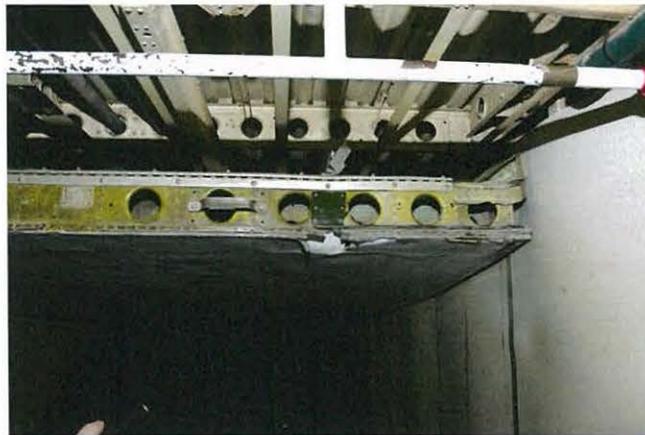
A post-flight inspection of the MA by the MP determined that all structures and systems were operating properly as designed; however, damage to the aft cargo door was identified (Tab V-16.6). The MA aft cargo door and Plexiglas ventilation door were serviceable immediately prior to the mishap (Tabs D-2, D-4 to D-10, V-16.5, V-16.8).

The MA sustained damage to the aft cargo door and the Plexiglas ventilation door (see Figure 6.1) during the mishap (Tabs S-2, U-3).

Figure 6.1. Damage to MA's aft cargo door. (Tab S-2)

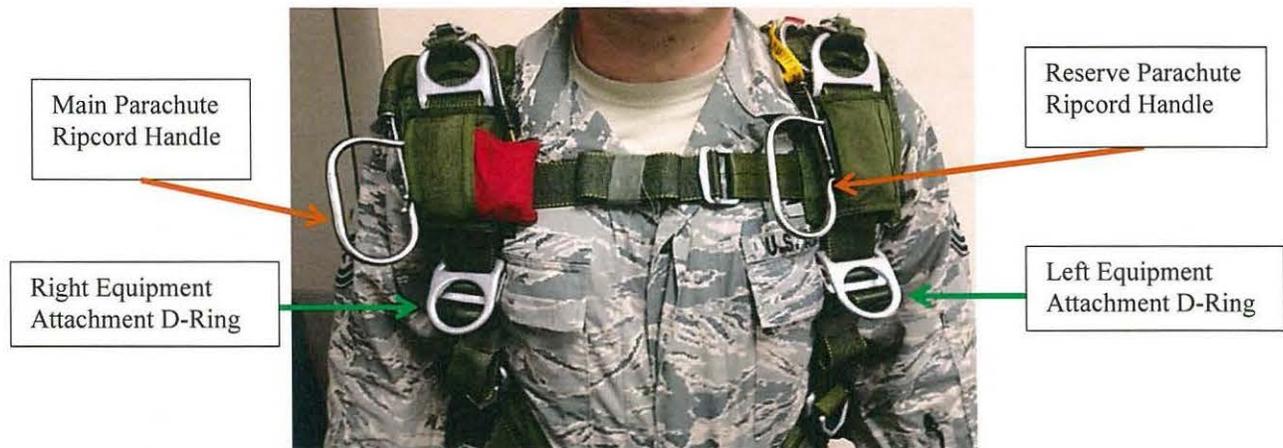
The characteristics of the MC-4 equipment attachment D-rings, which are similar in appearance, feel, and location to the lower portion of the ripcord handles, make it relatively easy to either (1) attach equipment inadvertently to a ripcord handle instead of the D-ring, or (2) catch equipment inadvertently on ripcord handle while attempting to attach equipment to the D-ring (see Figures 11.1, 11.2 and 11.3) (Tab GG-6, GG-7). Inadvertent attachments to the ripcord handles are a recognized hazard within the MFF community and have been known to occur (Tabs V-6.9, GG-6). This is exacerbated by wearing gloves, decreasing tactile feedback, and is more pronounced with the reserve ripcord handle, which is inboard of the left lift web, in line of sight from the parachutist's perspective (compare Figures 11.2 and 11.3) (Tab GG-7). At the time of the mishap, the MJ was seated, hooking up his rucksack and wearing Neumann Skydiving tackified gloves (Tabs V-1.4, X-3).

Figure 11.1. Note proximity of the equipment D-rings to the lower portion of the ripcord handles.

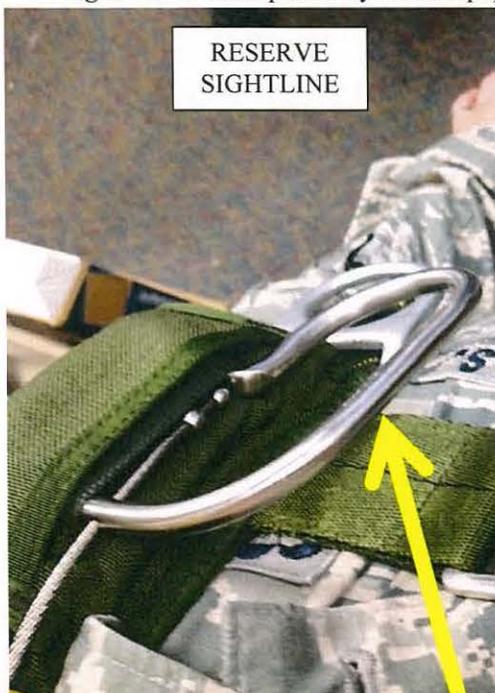
Figure 11.2. From a parachutist's point of view (looking down and left) the reserve ripcord handle is in line with the D-ring. (Yellow arrow indicates sightline)

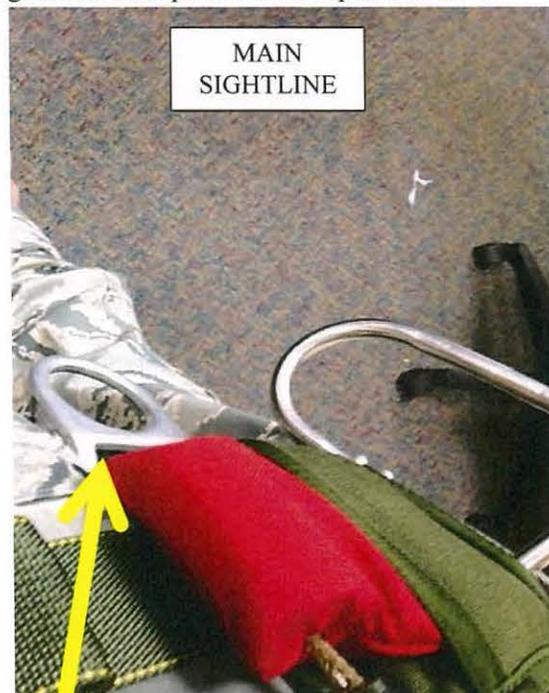
Figure 11.3. From a parachutist's point of view (looking down and right) there is space between the main ripcord handle and D-ring. (Yellow arrow indicates sightline)
